AFRL-ML-WP-TR-2001-4102

**FRACTURE BEHAVIOR OF A Si_3N_4 -BN
FIBROUS MONOLITH CERAMIC**

FINAL REPORT FOR PERIOD 01 OCTOBER 1999 - 01 APRIL 2001

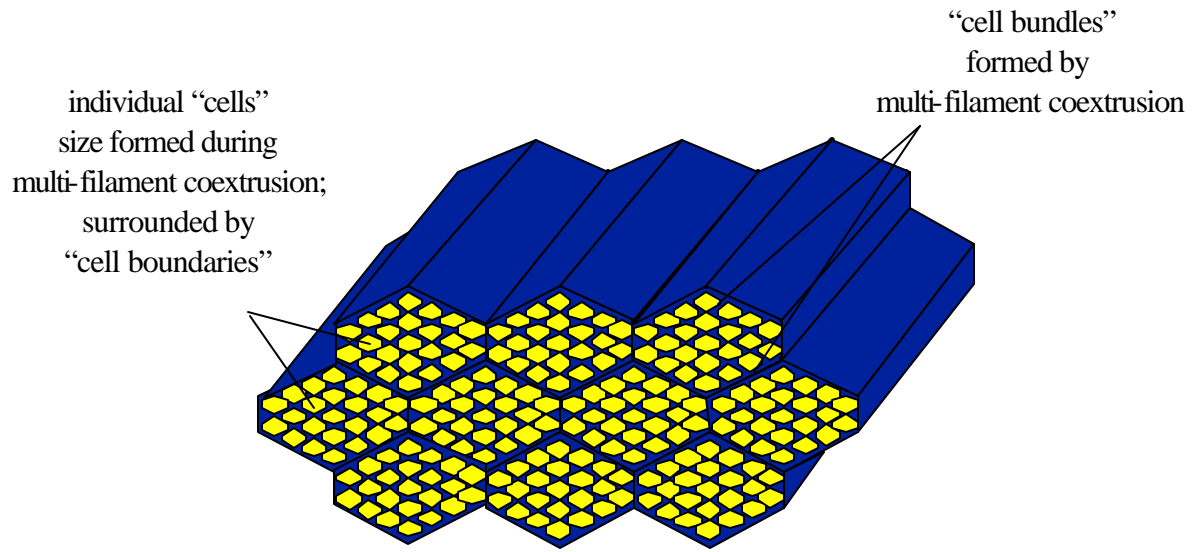
Figure 2.1 Schematic representation of a multi-filament coextruded material.

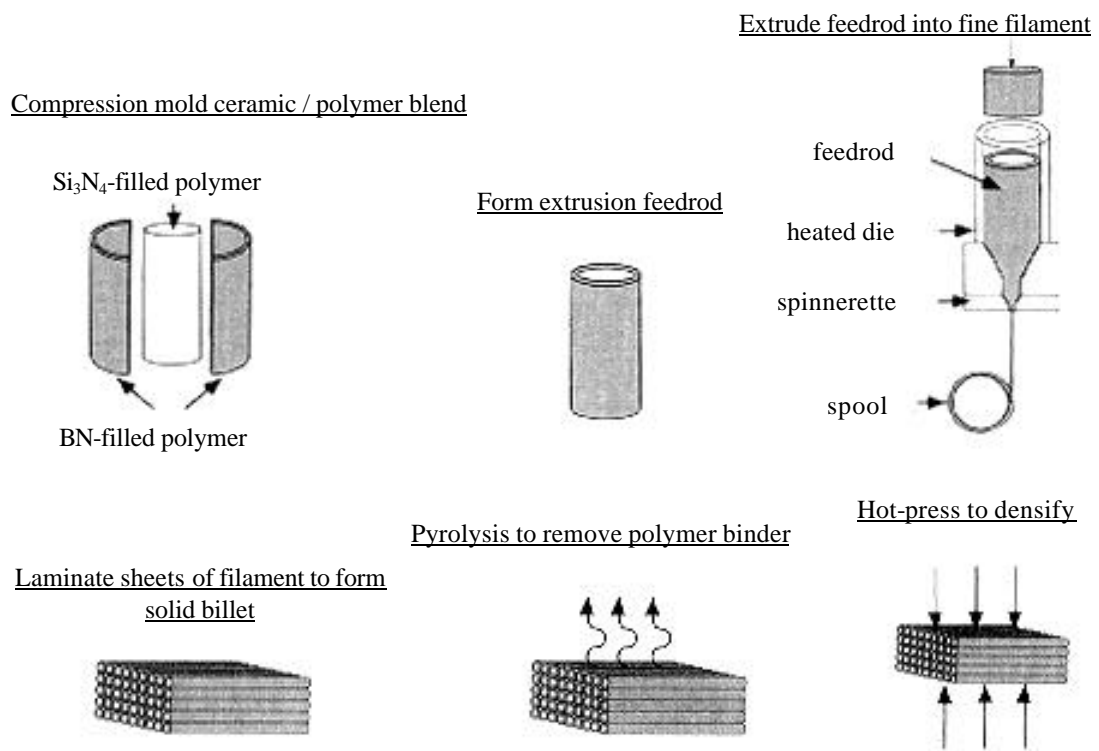
Figure 3.1 Schematic illustrations showing processing route to fabricate fibrous monoliths using coextrusion methods²².

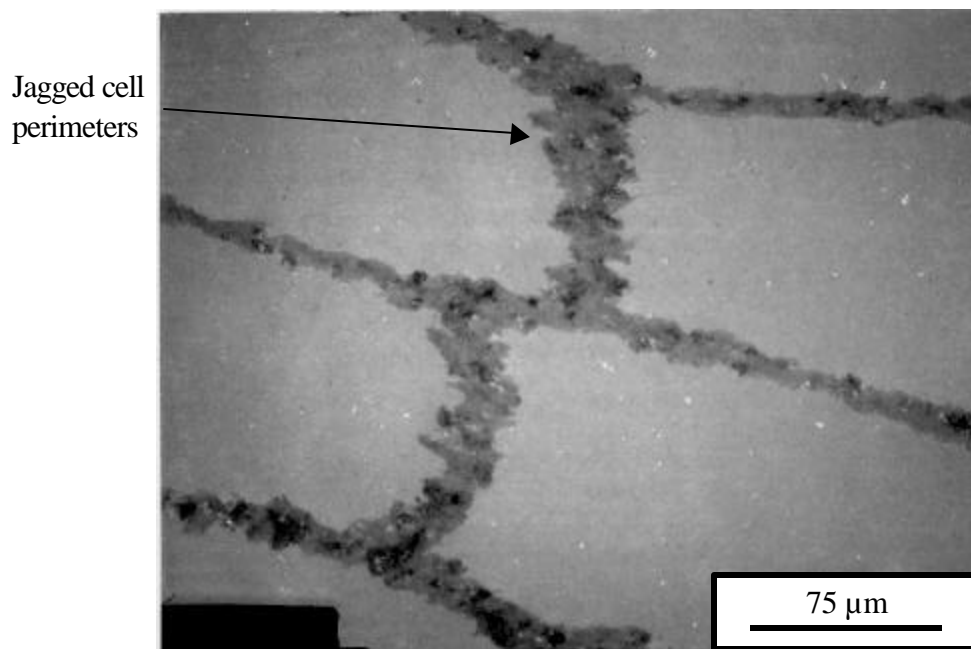
Figure 3.3 (b) Micrograph at 320x of Si_3N_4 -BN fibrous monolith showing the jagged perimeter formed on the individual cells during multi-filament coextrusion.

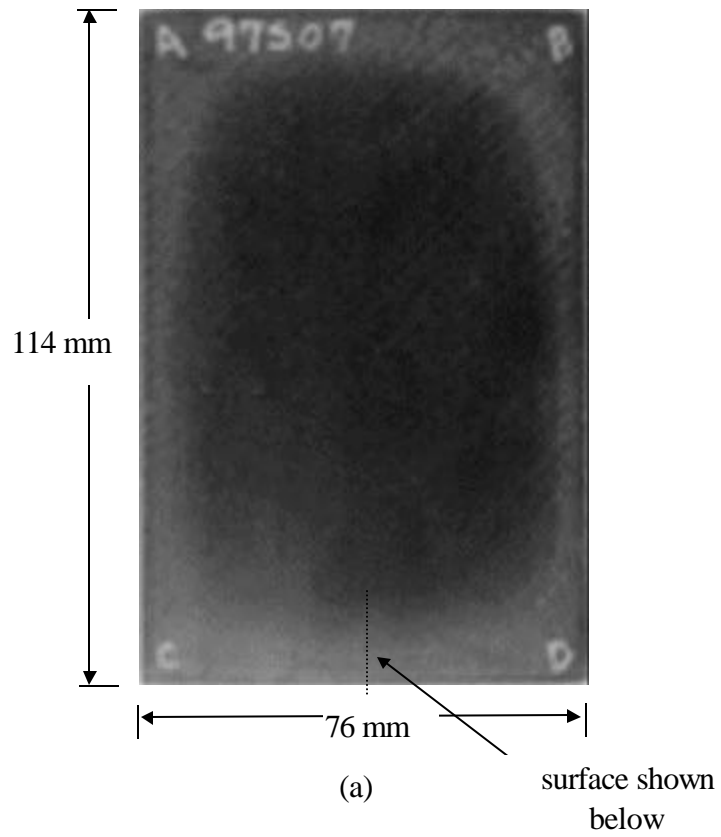
Figure 3.5 (a) Photograph of the plate material illustrating the edge defects from processing.

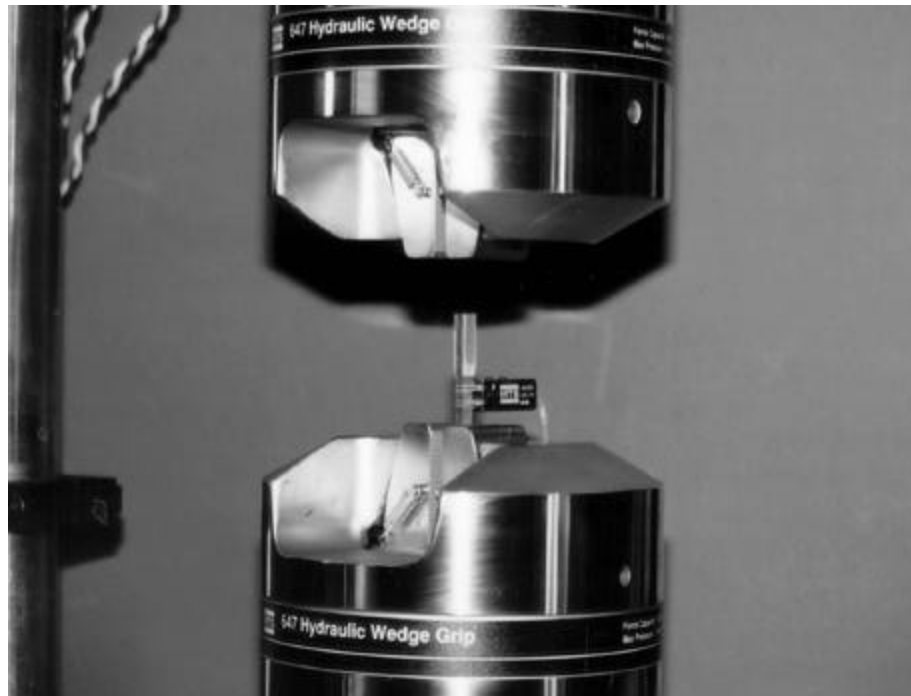
Figure 3.8 Photograph of the wedge grips used to test the straight-sided Si_3N_4 -BN fibrous monolith specimens.

The apparatus used for tensile testing included a MTS^{*} vertical servo-hydraulic test machine, a data acquisition computer, and a clip gage extensometer. The test system was equipped with wedge grips fitted with serrated grip inserts. Use of both DC and AC controllers allowed for tests to be conducted in load, strain, or stroke control. Specialized software was used to command the controllers to run the test and to acquire data through a 12-bit digitizer. See Figure 3.8 for a photograph the test frame with the wedge grips and wedge inserts. A calibrated clip gage extensometer was used to measure strain.

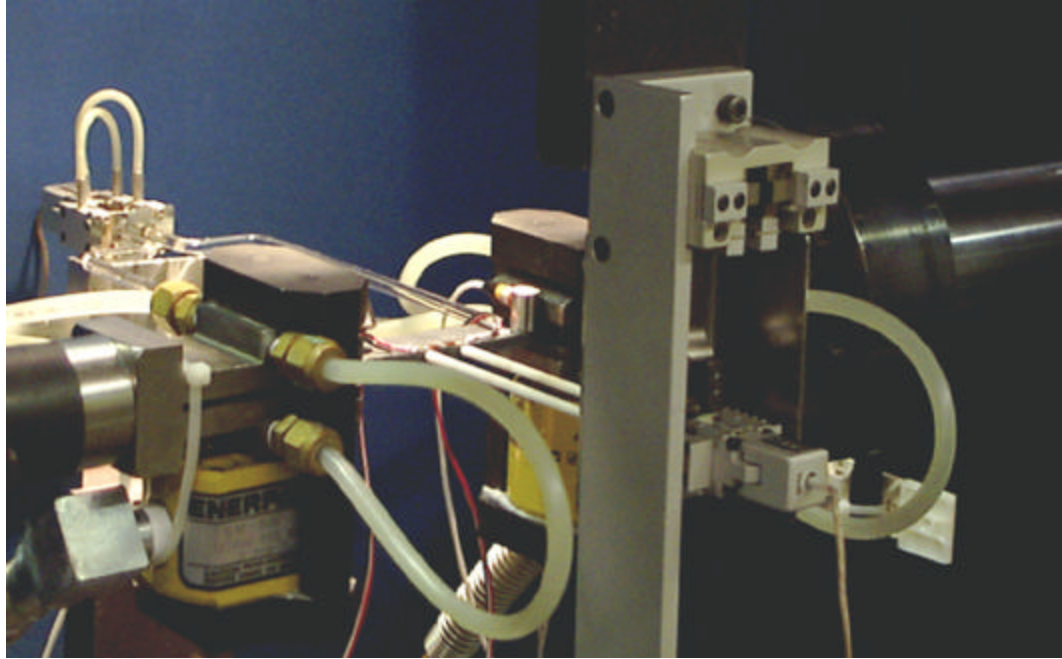
Figure 3.12 Photograph of the set-up used for room temperature fast fracture testing of MSE(T) specimens.

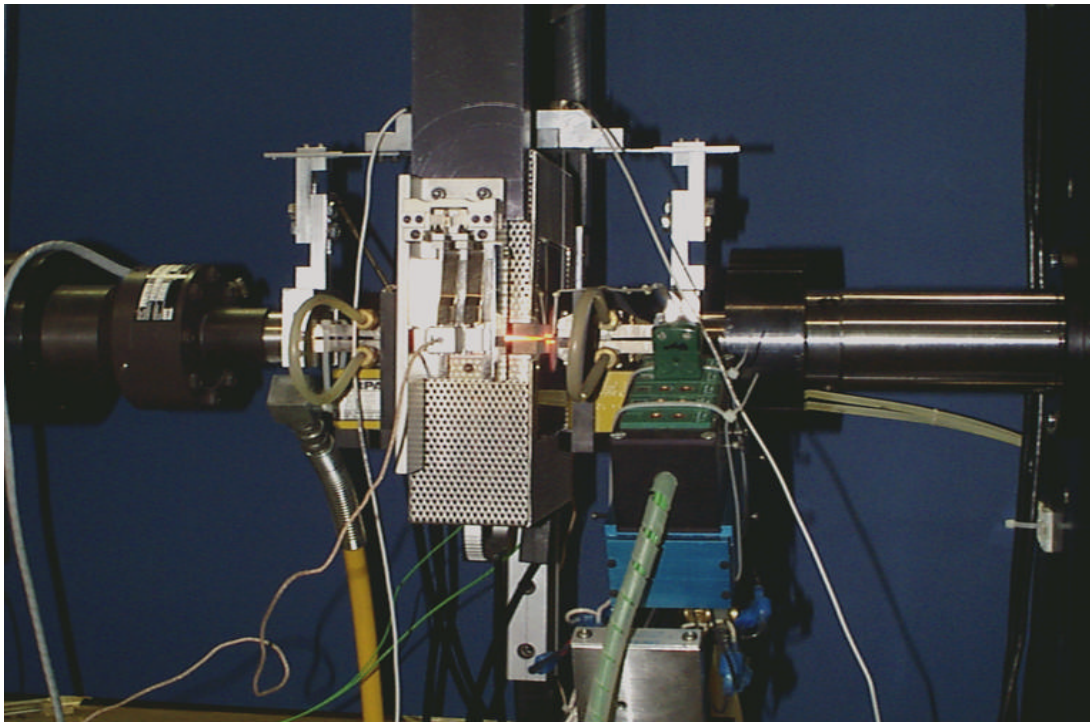
Figure 3.13 Photograph of the set-up used for high temperature fast fracture testing of MSE(T) specimens.

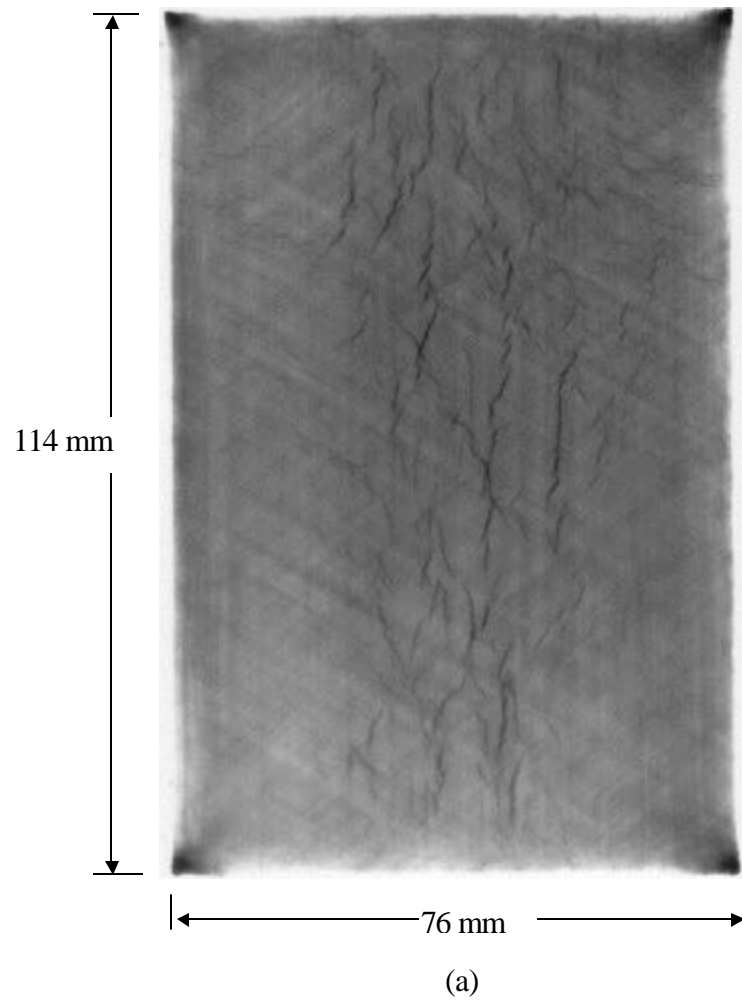
Figure 3.16 (a) & (b) X-ray radiographs of representative plates of the Si_3N_4 -BN fibrous monolith and neat Si_3N_4 materials respectively. A large number of microstructural defects are detected and the radiograph of the FM material whereas the neat material appears to be uniformly dense except near the edges.

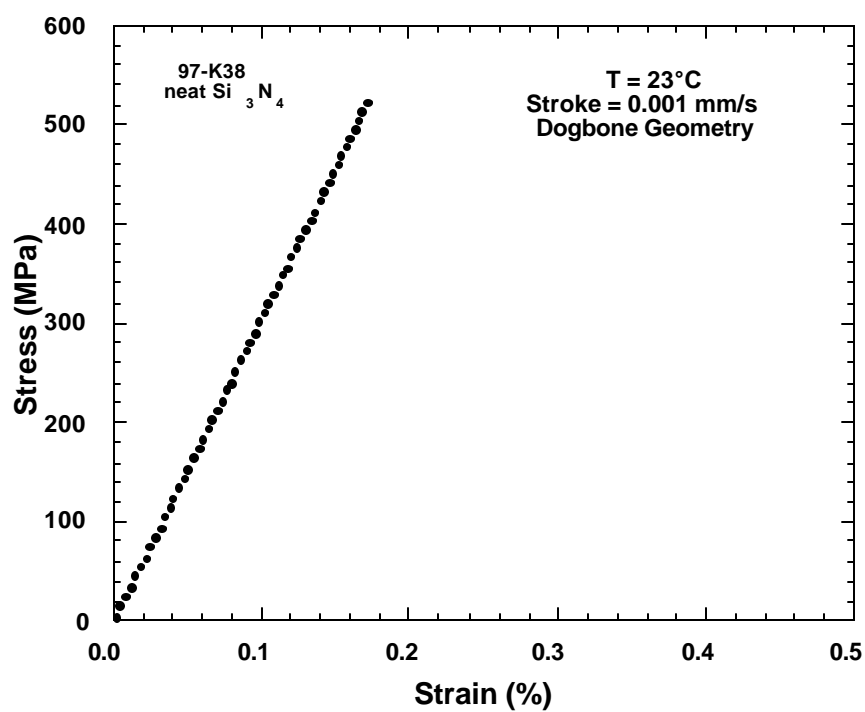
Figure 4.1 Tensile plot showing typical stress versus strain behavior of monolithic Si_3N_4 .

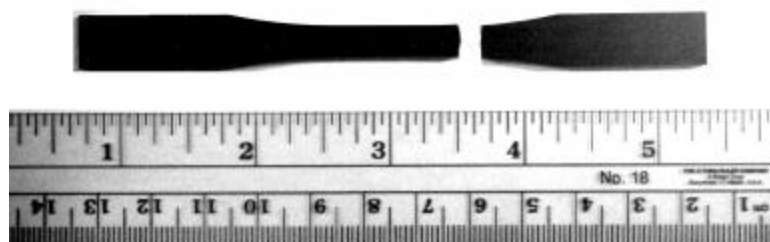
Figure 4.2 Photograph of a fractured monolithic Si_3N_4 tensile specimen illustrating the brittle fracture.

The fracture surfaces were flat and brittle in nature, as shown in Figure 4.2. The failure initiation site in the case of specimen 97-K34 was located on the surface of the

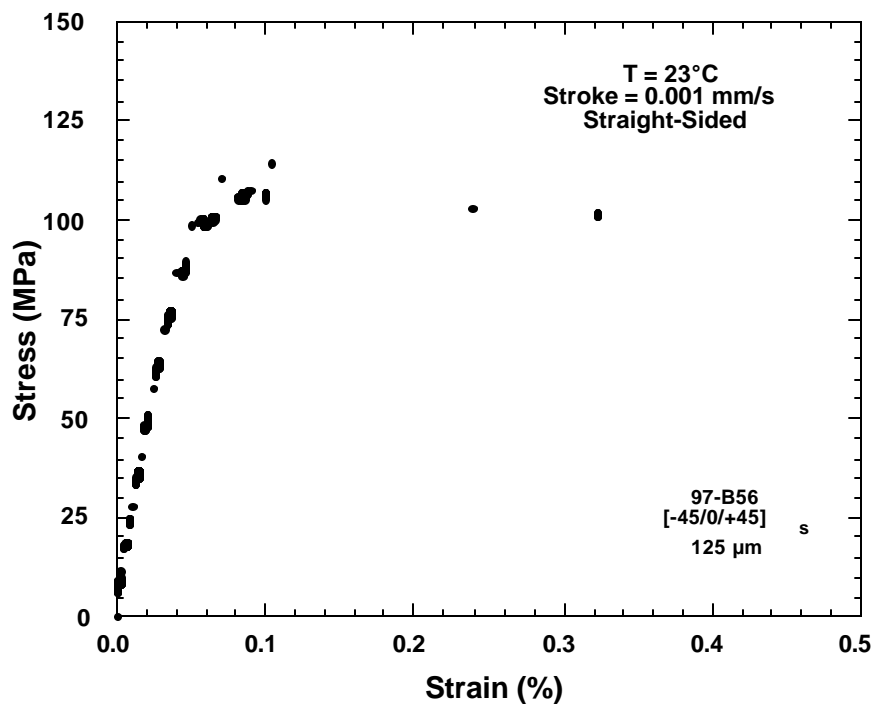
Figure 4.3 (a) Tensile plot showing typical stress versus strain behavior of Si_3N_4 -BN FM material with a nominal cell size of 125μm.

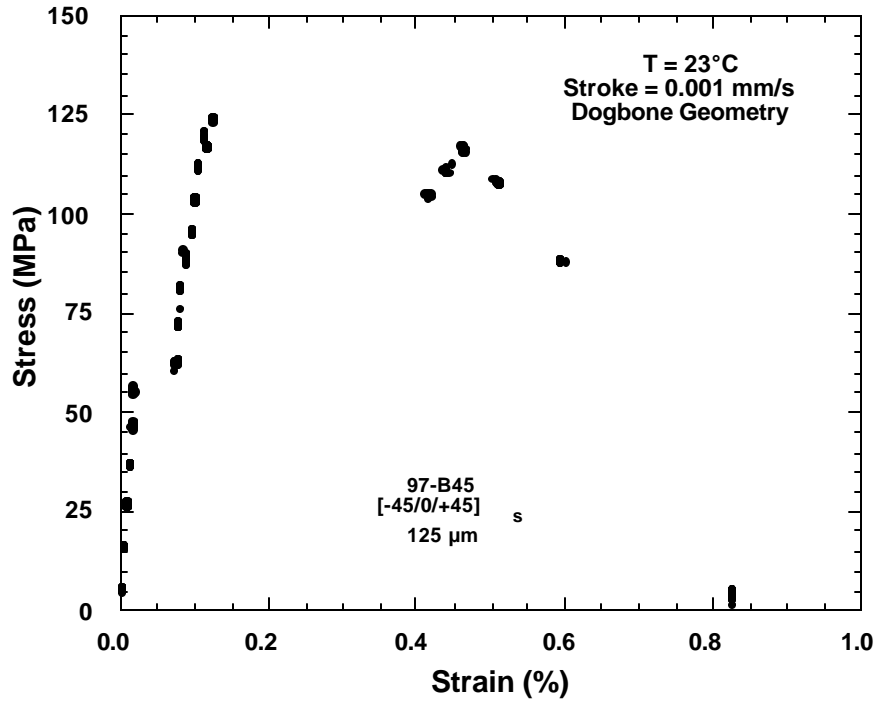
Figure 4.5 (a) Tensile plot showing stress versus strain behavior of Si_3N_4 -BN FM material with a nominal cell size of 125μm and dogbone geometry.

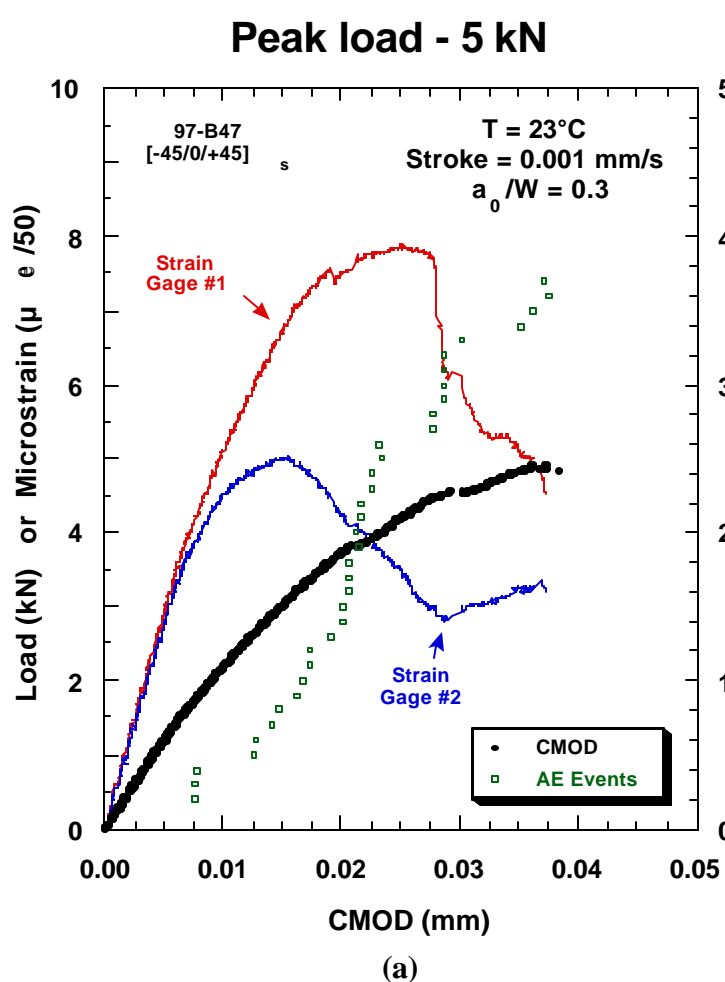
Figure 5.1 Results of fracture testing a FM specimen with the finer microstructure and an a_0/W of 0.3 at room temperature. (a) load or microstrain and AE count versus CMOD plot, (b) x-ray radiograph, (c) thermal diffusivity image, (d) ultrasonic c-scan, (e) acoustic emission histogram.

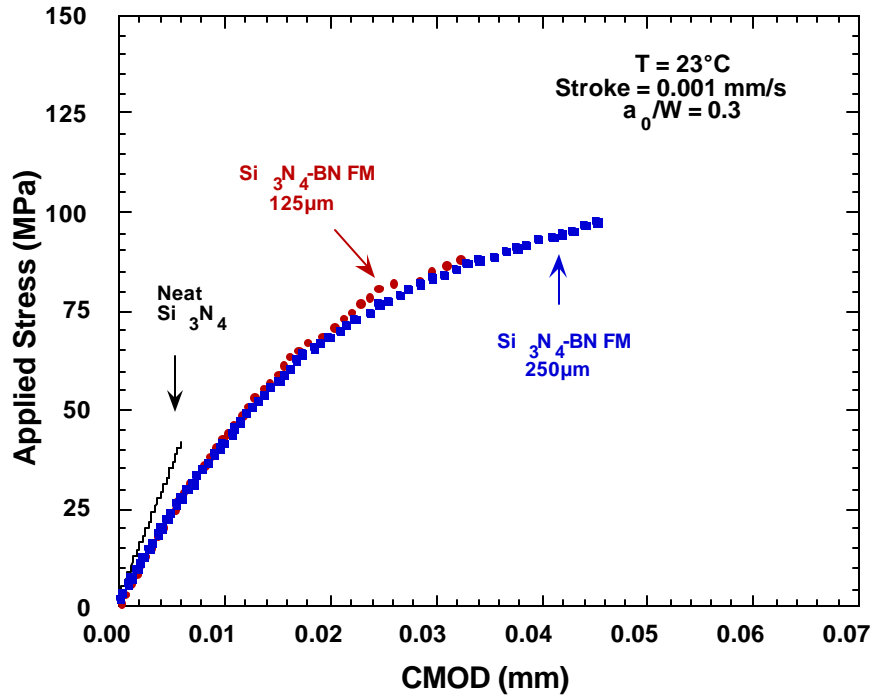
Figure 5.5 (a) Fracture behavior of Si_3N_4 -BN FM materials with an a_0/W of 0.3 as captured by an extensometer near the crack (notch) mouth opening.

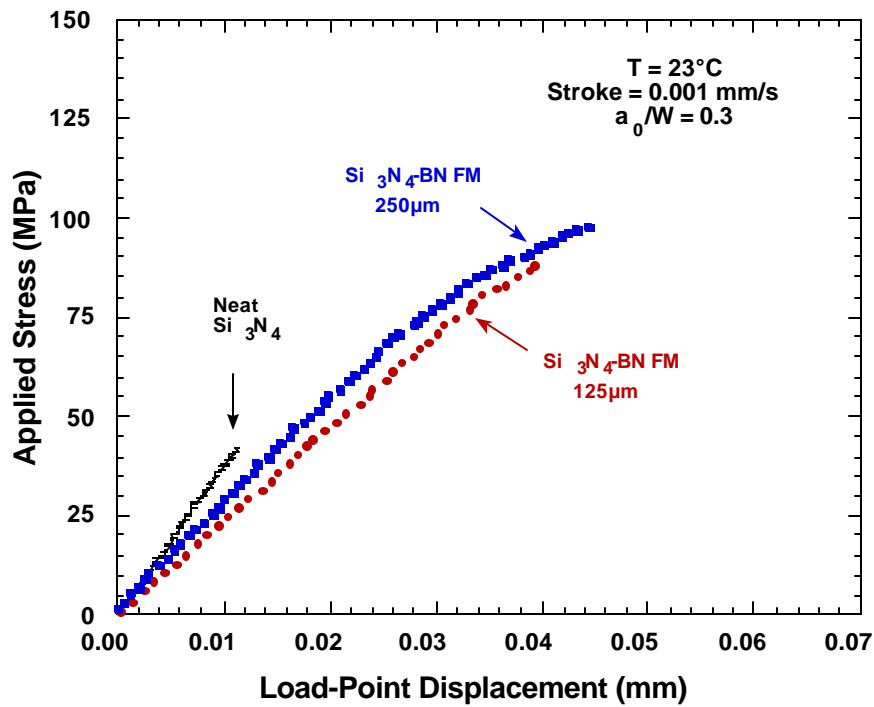
Figure 5.5 (b) Fracture behavior of Si_3N_4 -BN FM materials with an a_0/W of 0.3 as captured by an extensometer near the point of loading.

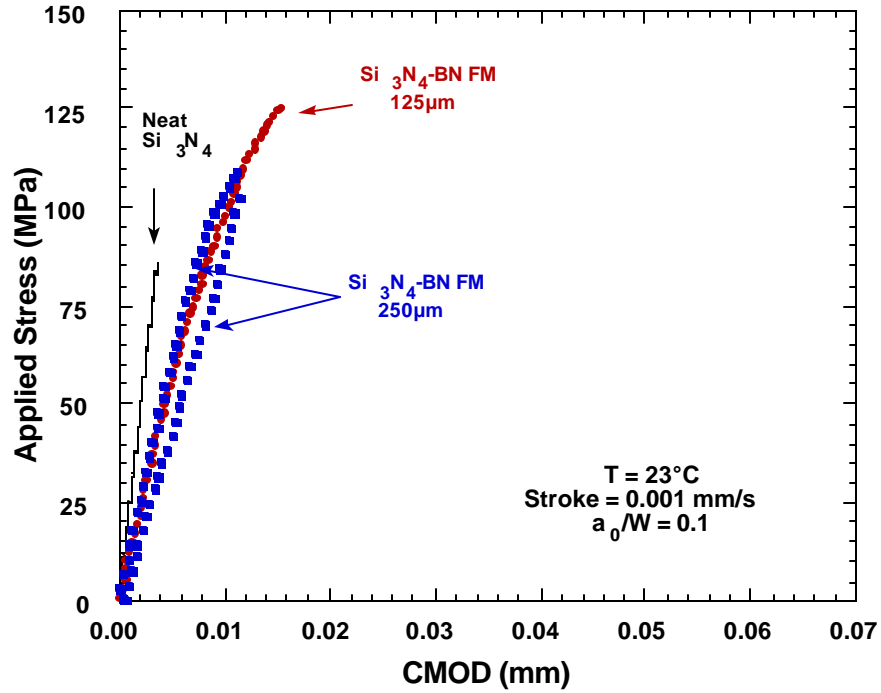
Figure 5.8 (a) Fracture behavior of Si_3N_4 -BN FM materials with an a_0/W of 0.1 as captured by an extensometer near the crack (notch) mouth opening.

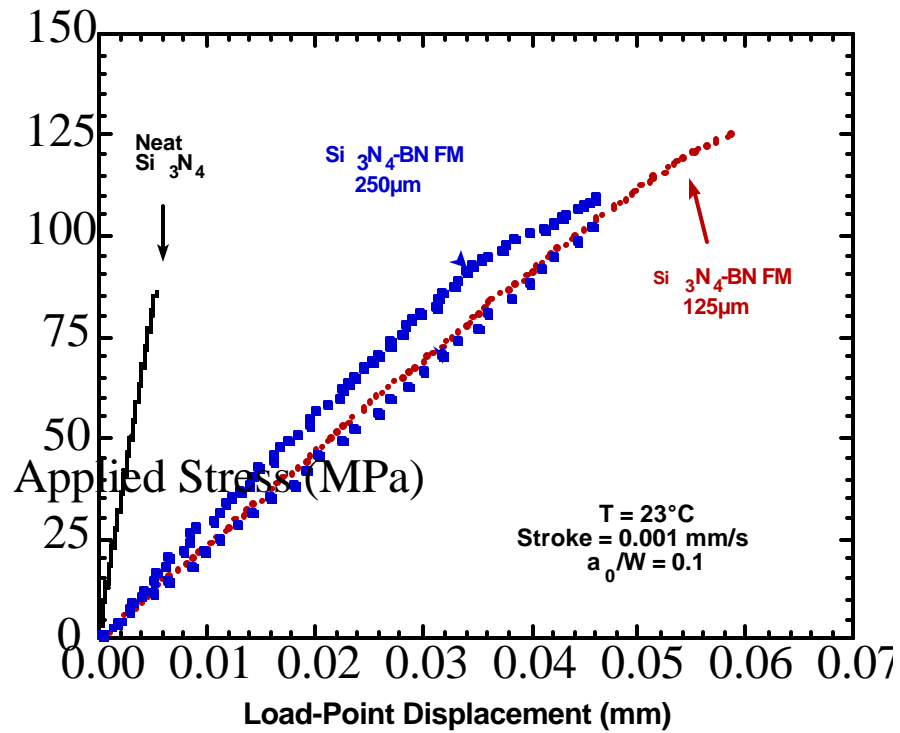
Figure 5.8 (b) Fracture behavior of Si_3N_4 -BN FM materials with an a_0/W of 0.1 as captured by an extensometer near the point of loading.

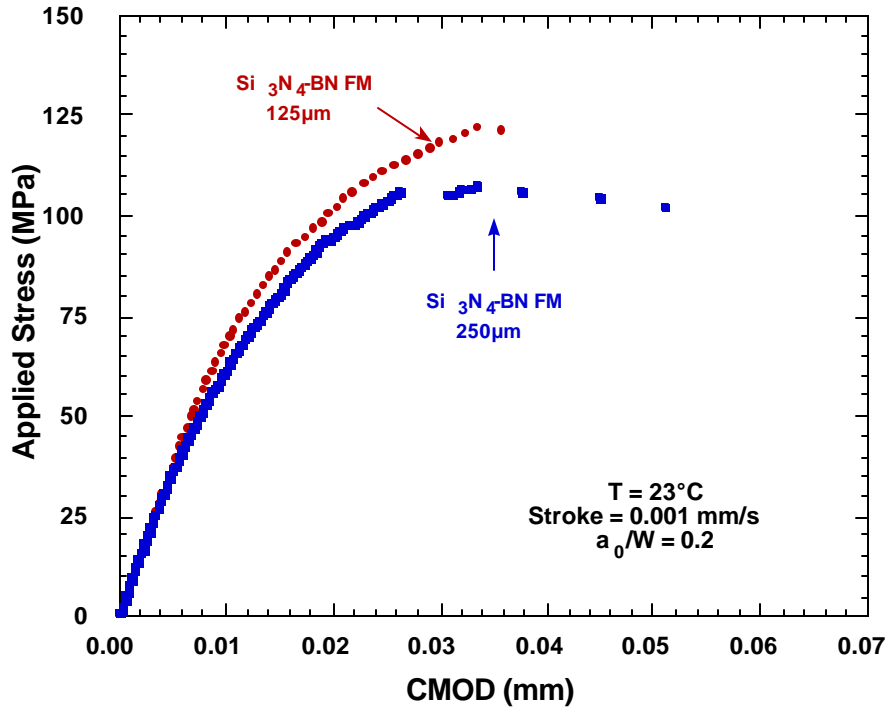
Figure 5.9 (a) Fracture behavior of Si₃N₄-BN FM materials with an a_0/W of 0.2 as captured by an extensometer near the crack (notch) mouth opening.

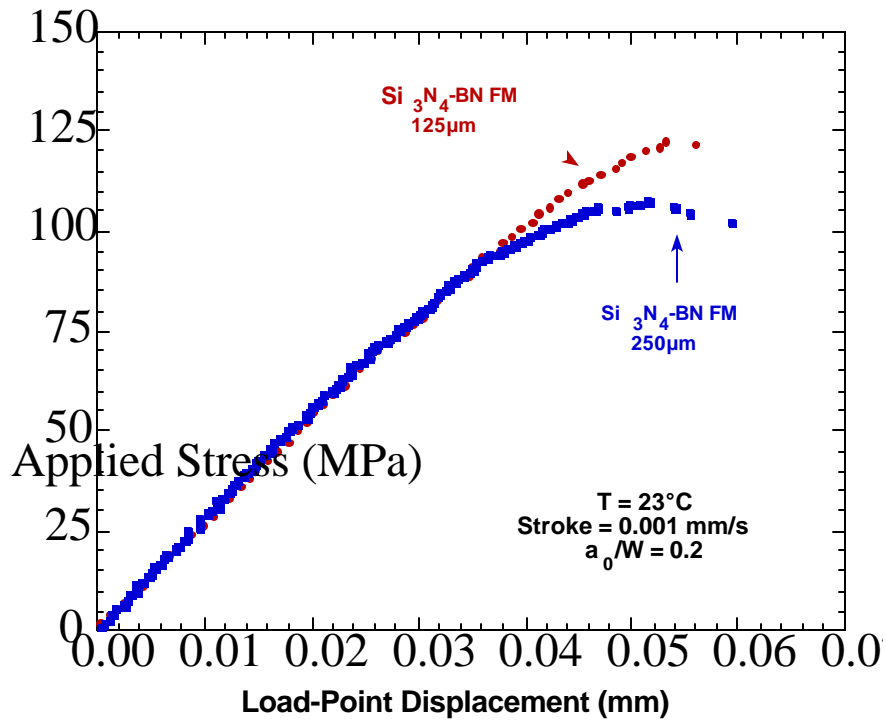
Figure 5.9 (b) Fracture behavior of Si₃N₄-BN FM materials with an a_0/W of 0.2 as captured by an extensometer near the point of loading.

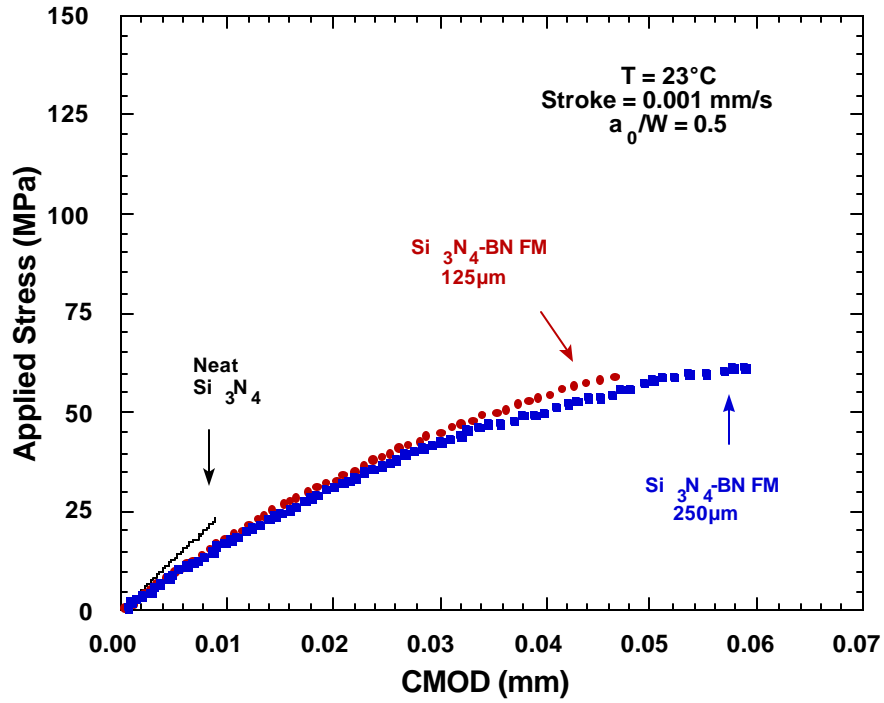
Figure 5.10 (a) Fracture behavior of Si_3N_4 -BN FM materials with an a_0/W of 0.5 as captured by an extensometer near the crack (notch) mouth opening.

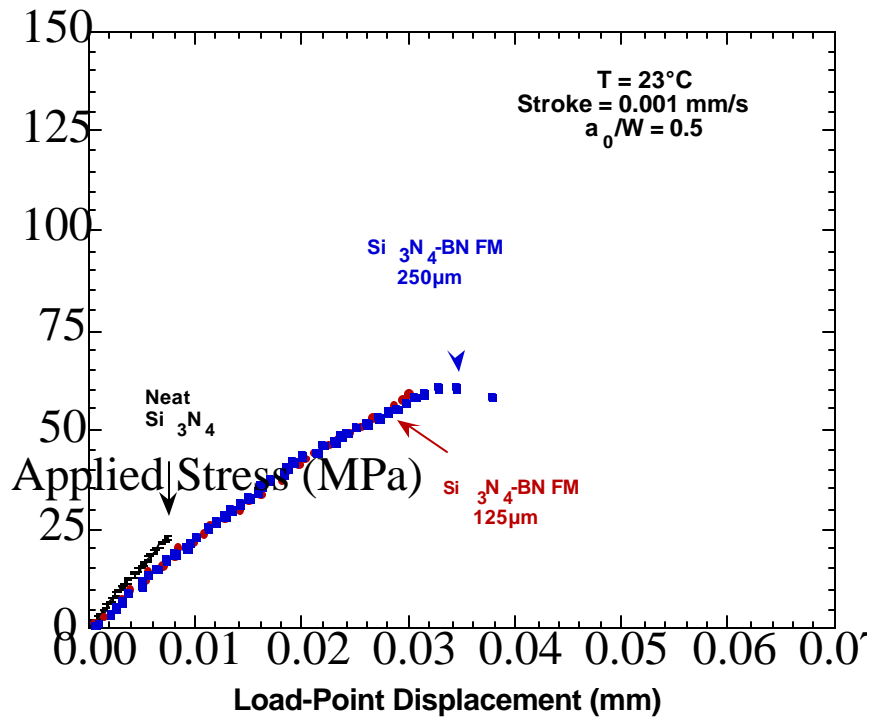
Figure 5.10 (b) Fracture behavior of Si_3N_4 -BN FM materials with an a_0/W of 0.5 as captured by an extensometer near the point of loading.

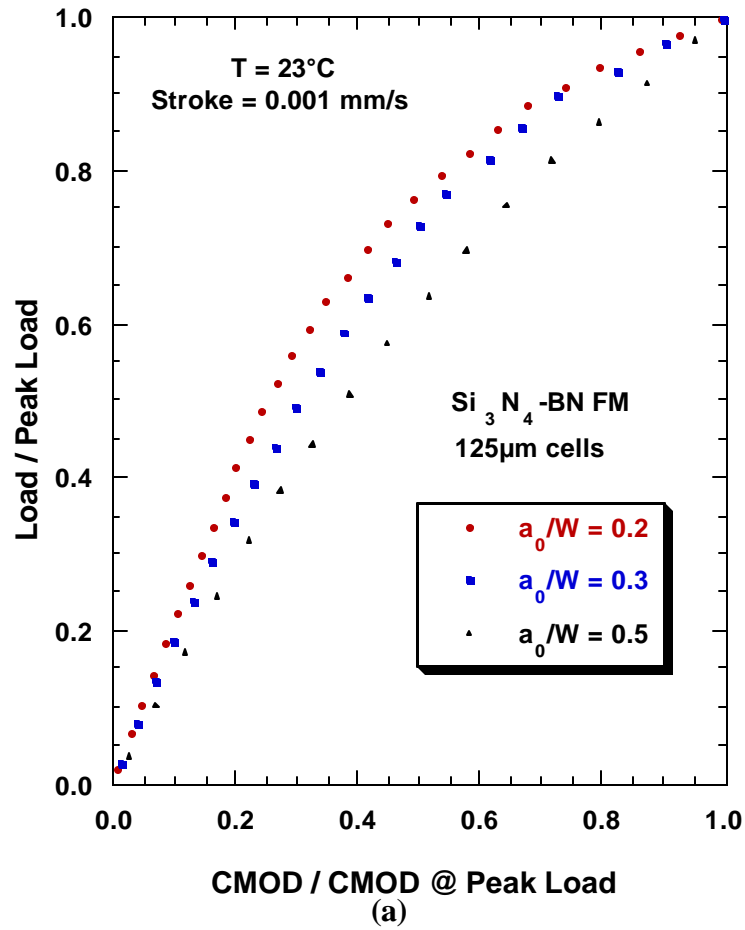
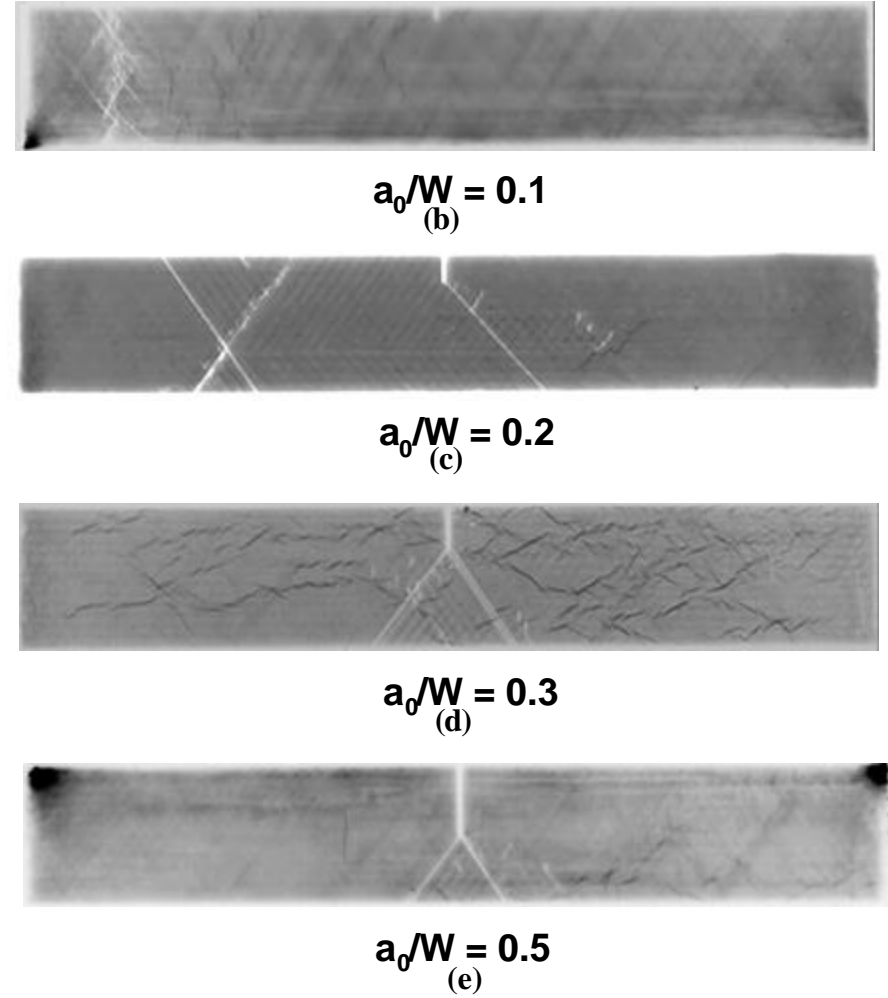
Figure 5.11 Comparison of the behavior and fracture morphologies for specimens of the 125 μm $\text{Si}_3\text{N}_4\text{-BN}$ fibrous monolith material with various notch lengths; (a) normalized load versus normalized CMOD plot, (b) through (e) x-ray radiographs of failed specimens with a_0/W 's = 0.1, 0.2, 0.3, and 0.5.

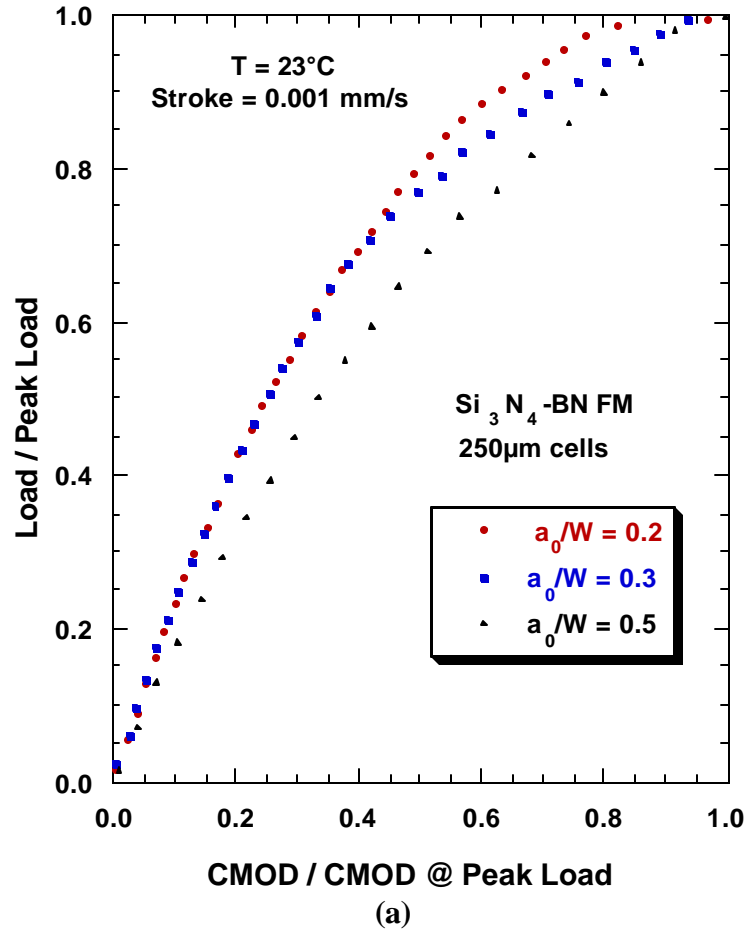
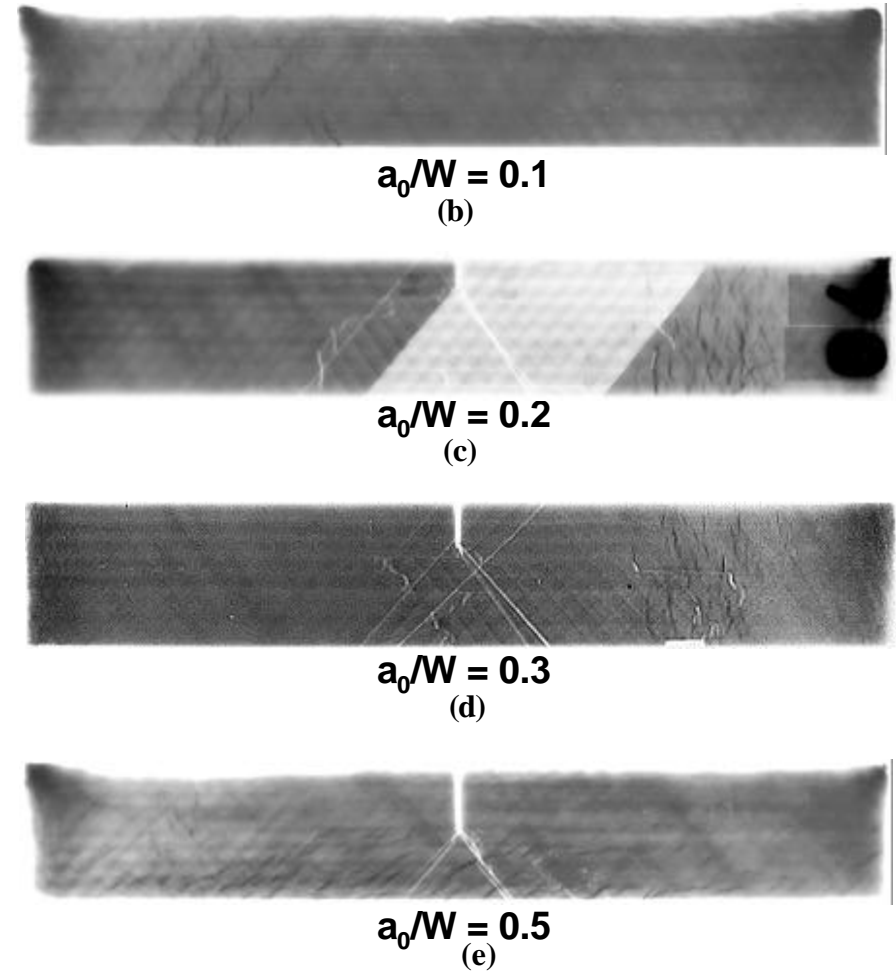
Figure 5.12 Comparison of the behavior and fracture morphologies for specimens of the 250 μm $\text{Si}_3\text{N}_4\text{-BN}$ fibrous monolith material with various notch lengths; (a) normalized load versus normalized CMOD plot, (b) through (e) x-ray radiographs of failed specimens with a_0/W 's = 0.1, 0.2, 0.3, and 0.5.

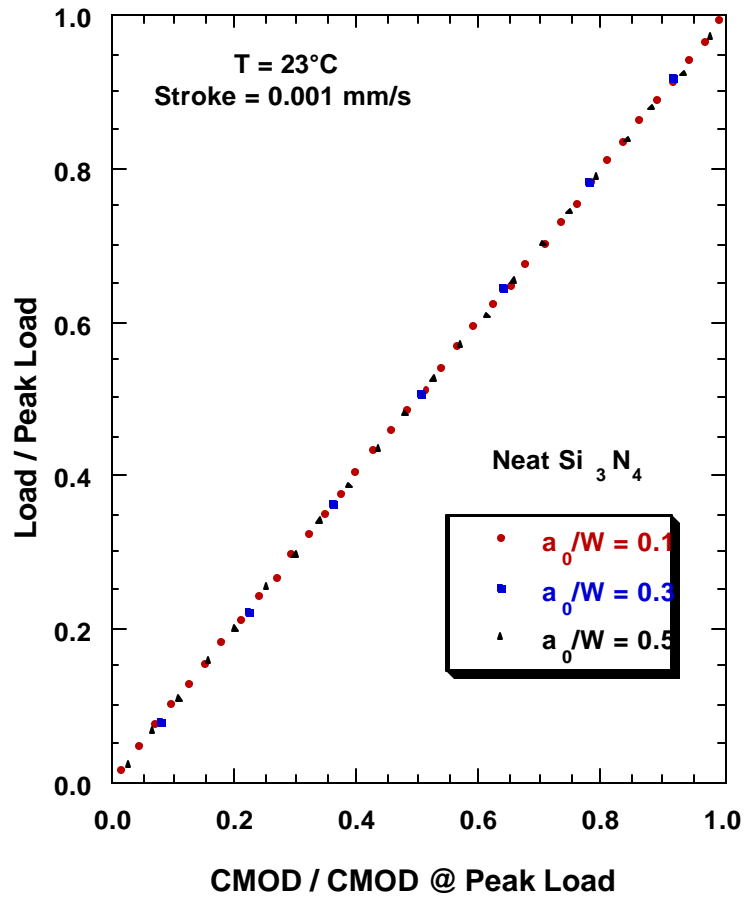
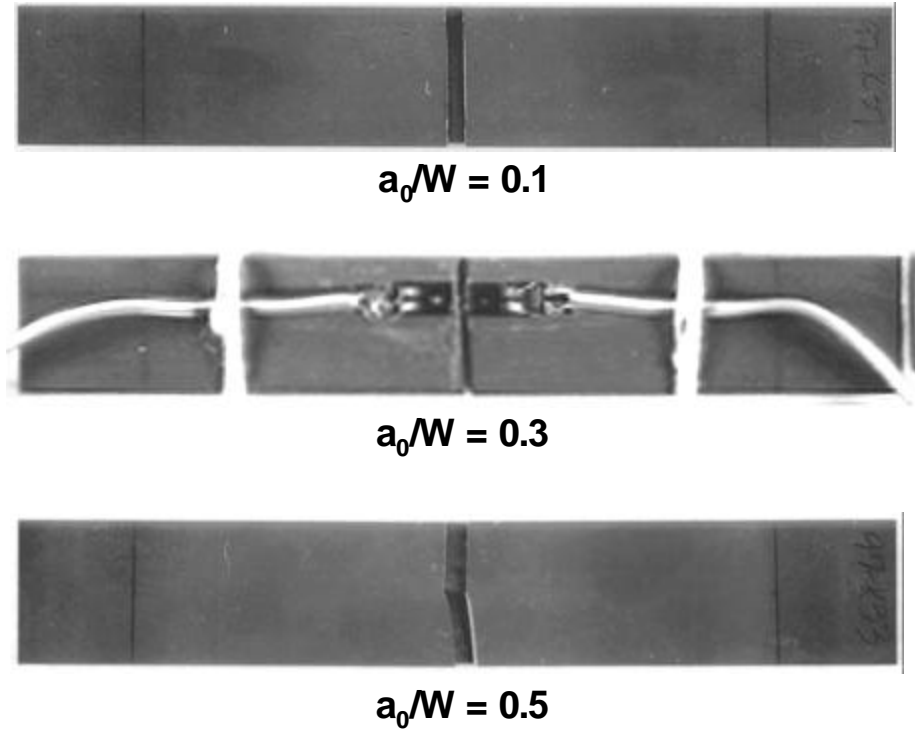
Figure 5.13 Comparison of the behavior and fracture morphologies for specimens of the neat Si_3N_4 material with various notch lengths; (a) normalized load versus normalized CMOD plot, (b) through (d) x-ray radiographs of failed specimens with a_0/W 's = 0.1, 0.3, and 0.5.

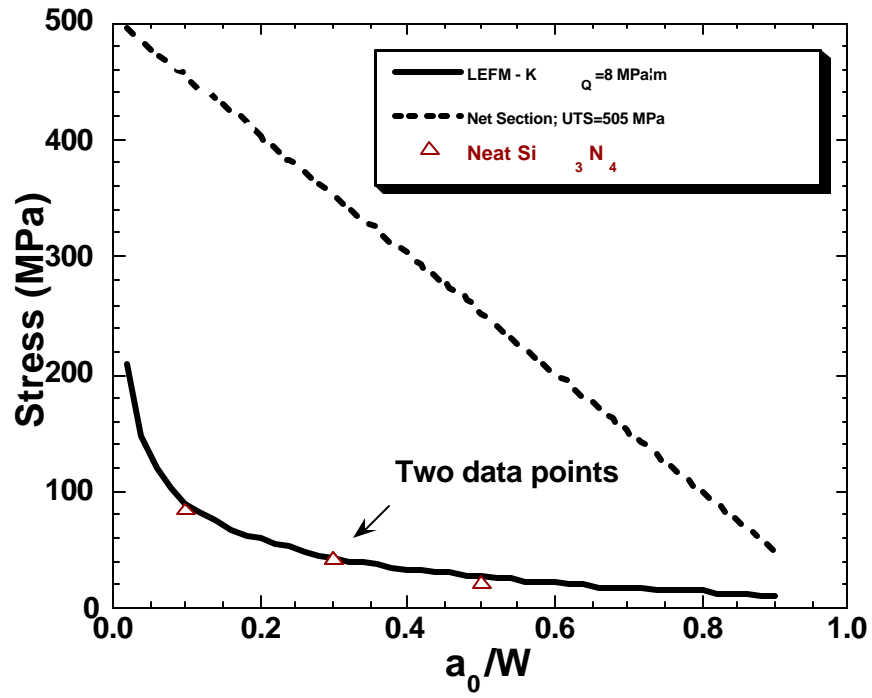
Figure 5.14 Effect of notch size for the neat Si_3N_4 material.

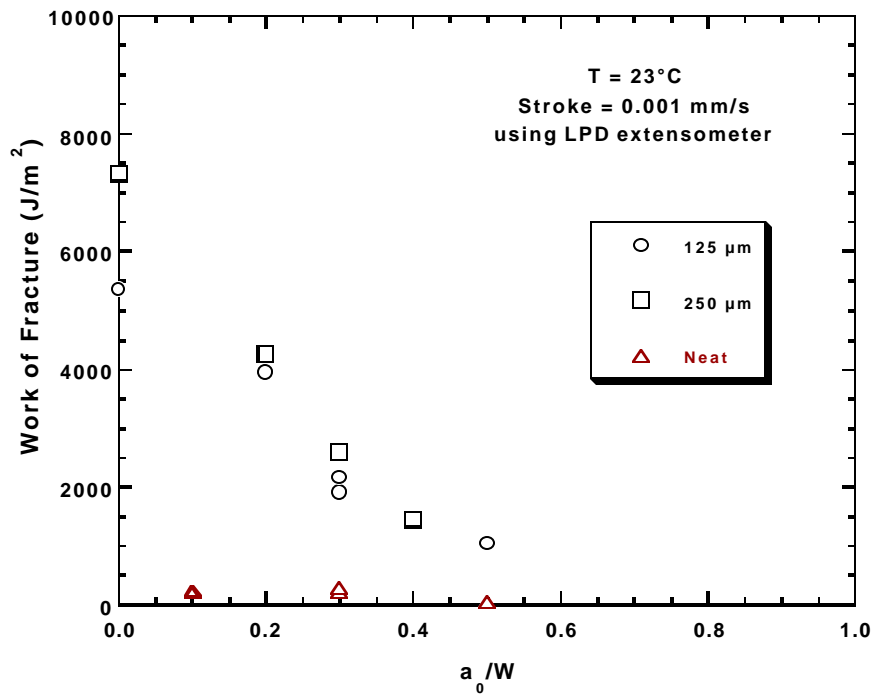
Figure 5.18 Total fracture energy per unit area as a function of notch size for the two fibrous monoliths and the neat materials.

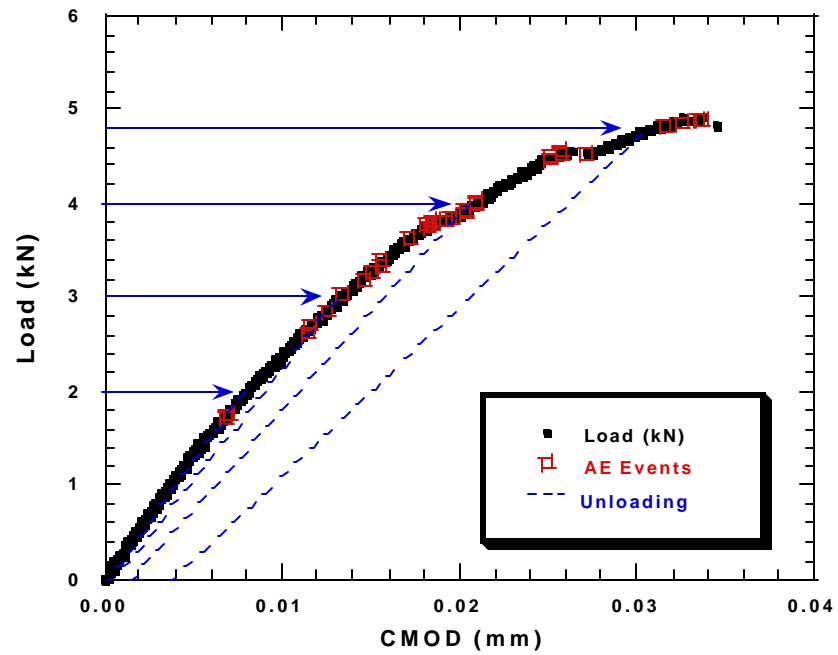
Figure 6.1 Curve obtained from fast-fracture testing which shows the unloading strategy to be used to run single load-unload and cyclic tests.

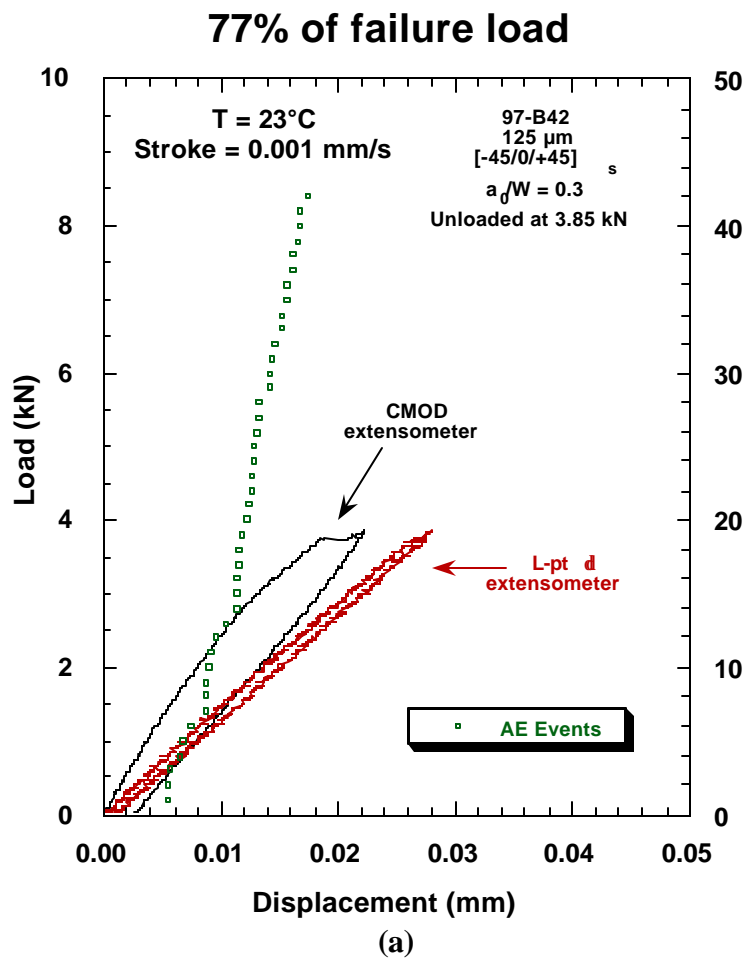
Figure 6.6 Results of load-unload testing a FM specimen with the finer microstructure and an a_0/W of 0.3 at room temperature. (a) load versus displacement plot, (b) x-ray radiograph, (c) thermal diffusivity image, (d) ultrasonic c-scan, (e) acoustic emission histogram.

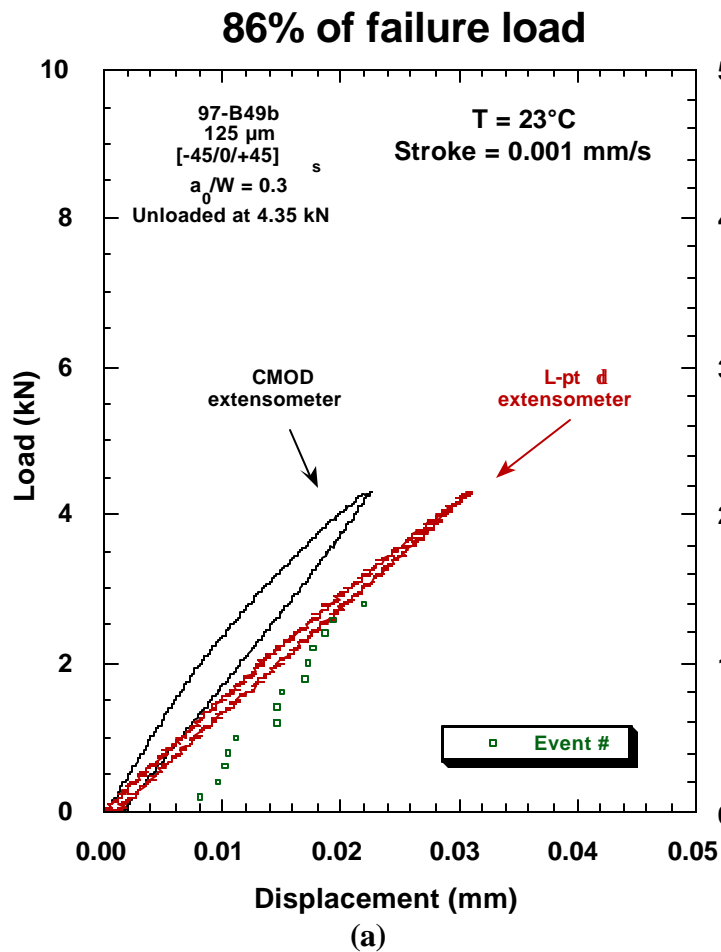
Figure 6.8 Results of load-unload testing a FM specimen with the finer microstructure and an a_0/W of 0.3 at room temperature. (a) load versus displacement plot, (b) x-ray radiograph, (c) thermal diffusivity image, (d) ultrasonic c-scan, (e) acoustic emission histogram.
